Published May 4th, 2016

Corroded Culvert is to Blame for Sinkhole

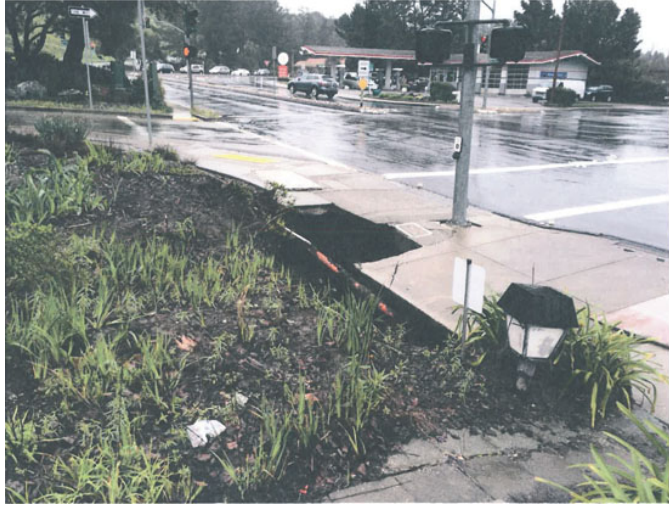
Sunday, March 13: The initial emergence of sinkhole.

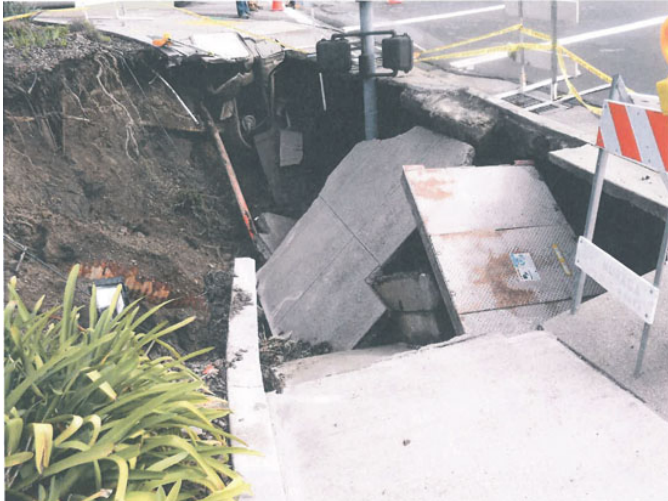
Monday, March 14: A traffic signal pole, a PG&E electrical switch vault and portions of the sidewalk collapsed into the sinkhole. Photos provided

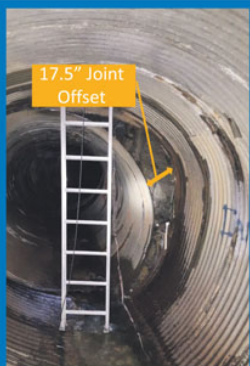
Figure 9: Joint Offset of CMP at Sinkhole Location

The presentation showed a 17.5-inch joint offset running all along the side of the culvert, caused by the shape alteration. When the rains started pouring last month, pressure increased on top of the pipe and large quantities of dirt were dragged from under the sidewalk into the pipe through the offset joint. After a while the road collapsed.

- Joint offsets of up to 17.5 inches
- Joint openings were visibly obstructed by debris from the sinkhole including concrete, irrigation piping and electrical conduit.
- Water flowing into the CMP through joint offsets at a rate of 1 to 2 gallons per minute following a dry period of approximately 10 days.

Repair alternatives were presented to the council. All agreed that removing the failed corrugated metal and replacing it with reinforced concrete was the way to proceed. "Daylighting" - bringing the culvert above ground - is too expensive; not doing anything is unsafe; and fitting a smaller pipe into the existing conduit would reduce the culvert capacity too much.

The town will replace the failed portion of the metal pipe with a concrete conduit. It will not fix the entirety of the corrugated section, because state funding might not be available for improvements beyond the immediately affected area.

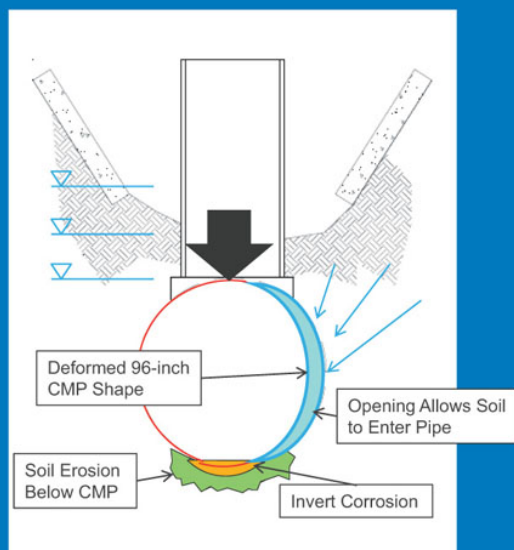
Figure 5: Animation of CMP Failure

Glen Anderson from consultants Schaaf & Wheeler made a presentation to the town council on April 27 of the forensic work that has been done in the sinkhole over the past weeks. Images of the film taken inside the culvert were enough to bring their point home. It showed a pipe where corrosion was everywhere, to the point that the bottom was gone in some places, not supporting the top of the pipe, and resulting in its deformation. The
