Published May 4th, 2016

Corroded Culvert is to Blame for Sinkhole

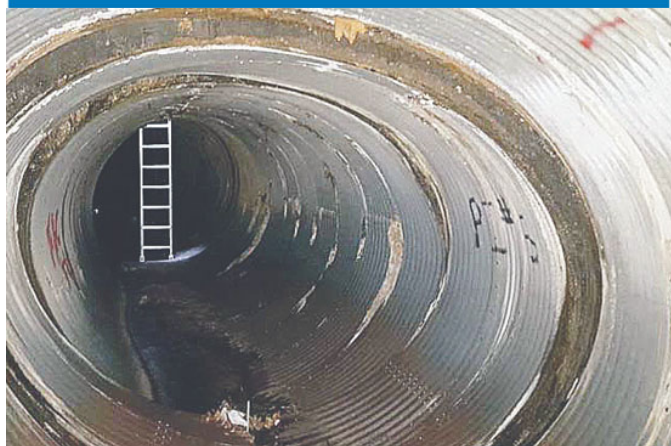
The presentation showed a 17.5-inch joint offset running all along the side of the culvert, caused by the shape alteration. When the rains started pouring last month, pressure increased on top of the pipe and large quantities of dirt were dragged from under the sidewalk into the pipe through the offset joint. After a while the road collapsed.

Glen Anderson from consultants Schaaf & Wheeler made a presentation to the town council on April 27 of the forensic work that has been done in the sinkhole over the past weeks. Images of the film taken inside the culvert were enough to bring their point home. It showed a pipe where corrosion was everywhere, to the point that the bottom was gone in some places, not supporting the top of the pipe, and resulting in its deformation. The

Repair alternatives were presented to the council. All agreed that removing the failed corrugated metal and replacing it with reinforced concrete was the way to proceed. "Daylighting" - bringing the culvert above ground - is too expensive; not doing anything is unsafe; and fitting a smaller pipe into the existing conduit would reduce the culvert capacity too much.

The town will replace the failed portion of the metal pipe with a concrete conduit. It will not fix the entirety of the corrugated section, because state funding might not be available for improvements beyond the immediately affected area.
