## A clean, well- lighted place for sewage

By Sora O'Doherty

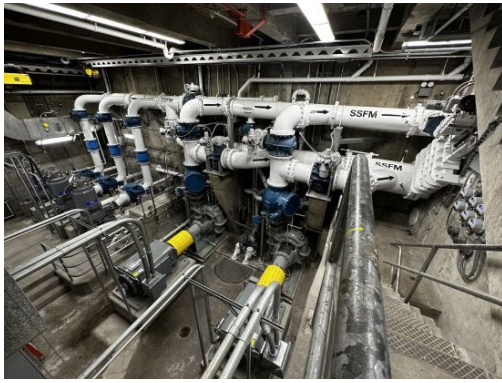
The newly refurbished Orinda main pumping station behind Theatre Square pumps Orinda sewage up and over the hill and out to the treatment plant in Martinez. Photo Sora O'Doherty

The Theatre Square station houses five pumps. Two of the pumps used to operate on diesel, but have been replaced with electric pumps. Three are called "dry weather" pumps. They run about 95% of the time. There are also two larger "wet weather" pumps that kick in when needed to handle even the highest flows that can be caused by storm water seeping in through manhole covers, or joints in the pipes, although the pumps do not handle storm water per se. Some years these large pumps do not run at all. This year, Gellerman says, was a good test for the big pumps, which ran a lot during the heavy winter storms.

The exterior of the pumping station was built in the late 1950s. The old diesel engines, which also dated from the '50s, were very loud and polluting. The new electric pumps, which operate with a generator backup, are not just on/off pumps, but operate with variable frequency drives. They ramp up or down as needed. Although they run continuously, they run at lower capacity during the night. Usually only one pump is running, and they rotate which pump about once a week. The pumps are housed on the lower level of the station, well below ground.

A new 900-kilowatt generator is included with this upgrade and powers the pumps in the event of an electrical power outage. The generator is powered by diesel, but meets very stringent air quality controls to limit emissions.
